Leak Detection Report

Boyup Brook Swimming Pool

Distinctive Pools were requested to perform a leak detection and condition analysis of the Swimming Pool at Boyup Brook on Thursday the 19th March 2026.

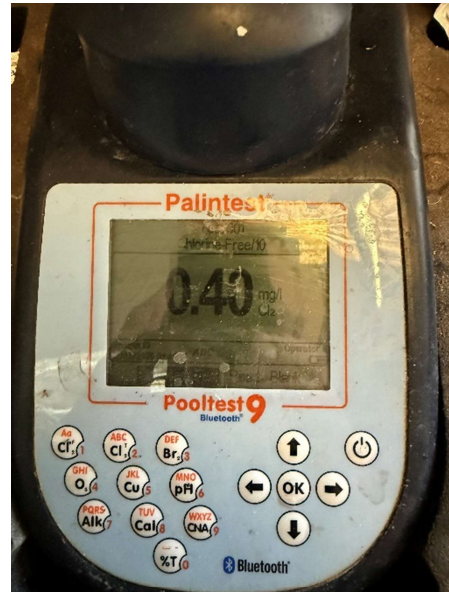
Tap water chlorine test (DPD1)

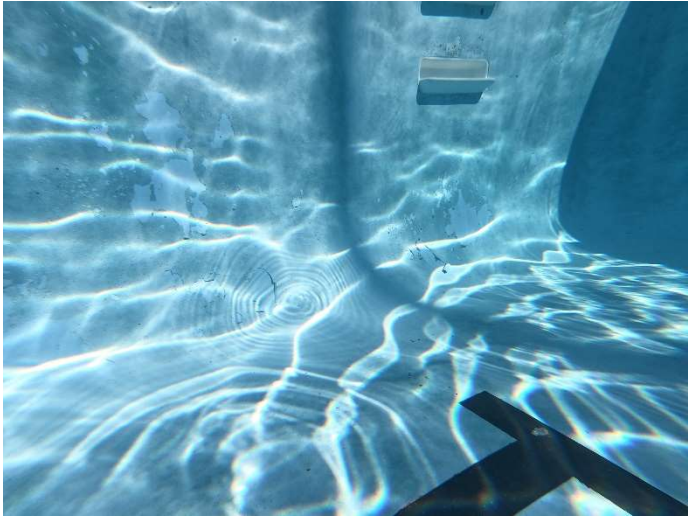
Pool paint peeling

- Pool paint interior is bubbling, cracking and missing in many places
- Waterline tiles are in poor condition – cracked, missing in multiple places
- Coping to top of pool is drummy and failing significantly over the entire pool

We would suggest that cosmetic repairs (tile, paint and capping) be done in conjunction with the leak repair works

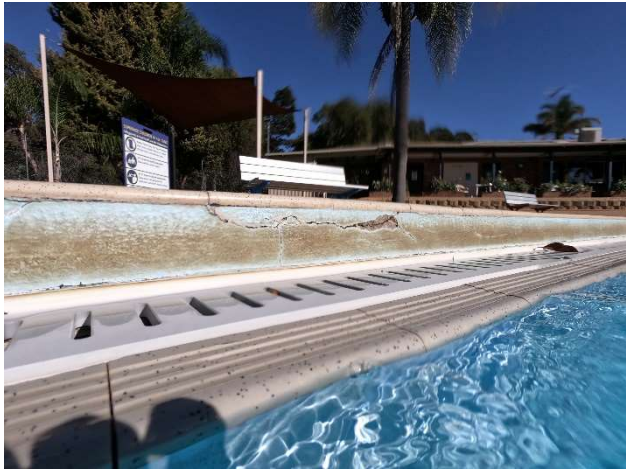
Capping screed cracking

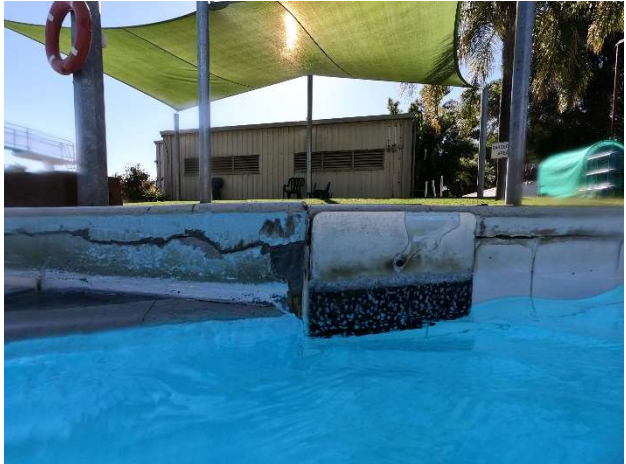
Capping screed cracking

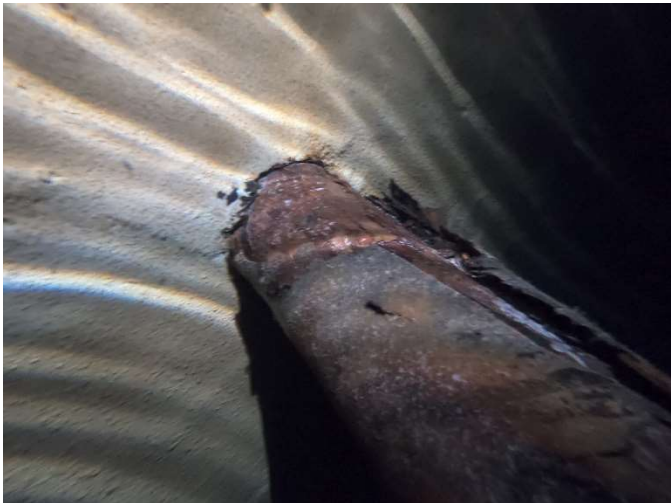
Original pipe penetrations – NO LEAKS
