Leak Detection Report

Boyup Brook Swimming Pool

Distinctive Pools were requested to perform a leak detection and condition analysis of the Swimming Pool at Boyup Brook on Thursday the 19th March 2026.

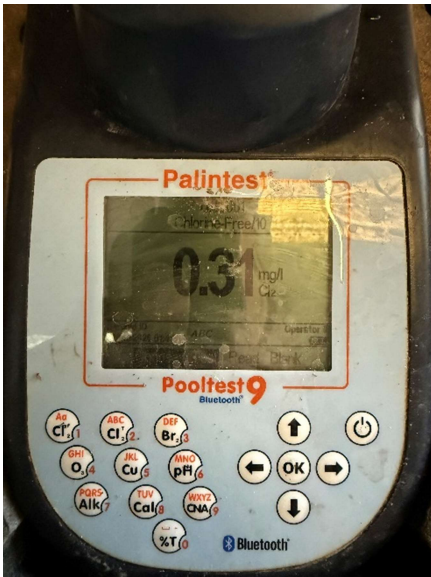
Ground water chlorine test (DPD1)

- Swimming pool control joints are leaking - particularly towards the dive bowl area
- Groundwater testing in drainage pits near dive bowl show water contains small traces of chlorine (0.34ppmm)

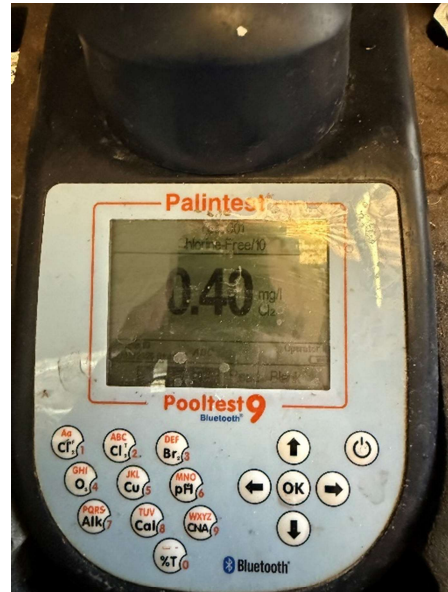
Tap water chlorine test (DPD1)

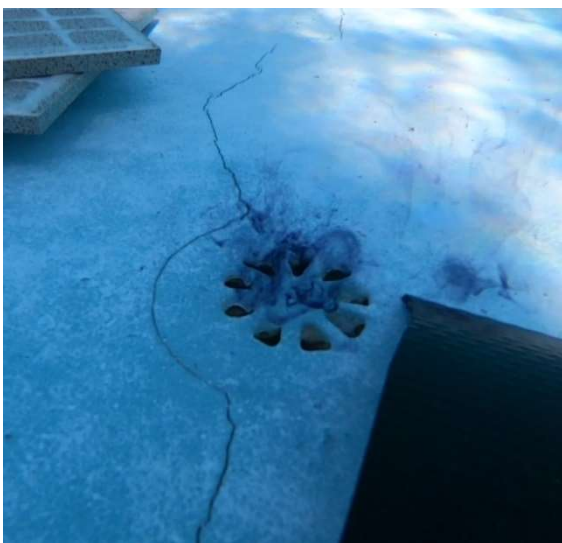
Floor returns – no sign of leaking with dye

- Some gutter tiles have been replaced in the past, with others missing
- Pool returns - no signs of leaking – Pressure testing not possible without breaking open floor returns to insert test plugs.

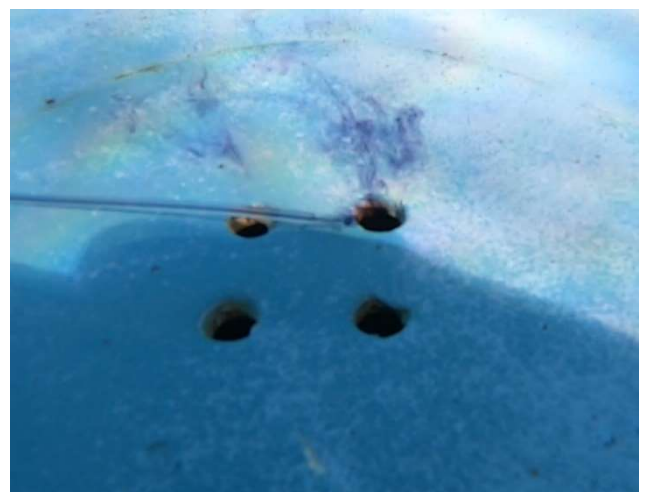
Floor returns – no sign of leaking with dye

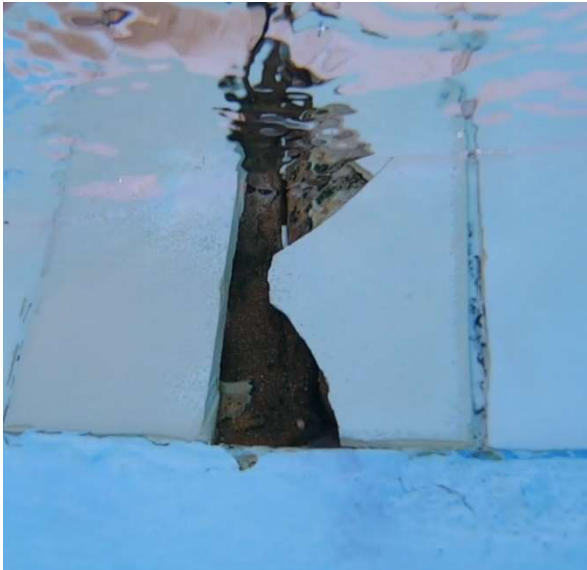
Control joint leaking – tile cracked

The leak has been determined to be significant in the control joints. It is unclear the extent of the joint failure so we would recommend the repair of all joints to the pool.

We recommend the joint be treated with the [Sikadur-Combiflex® SG System](#)

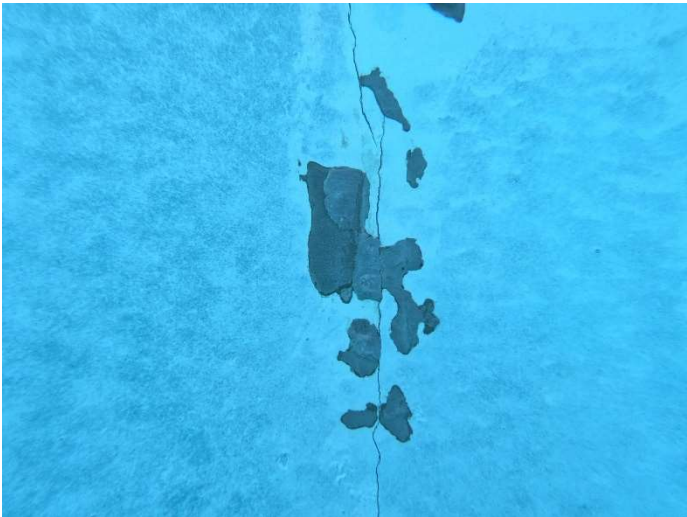
Control joint cracking – No silicon jointing material visible – no evident leak

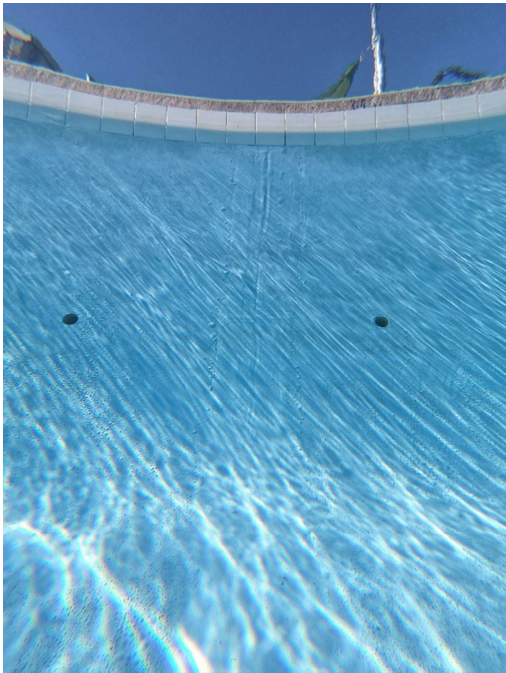
Dive Bowl existing crack repair – no deterioration

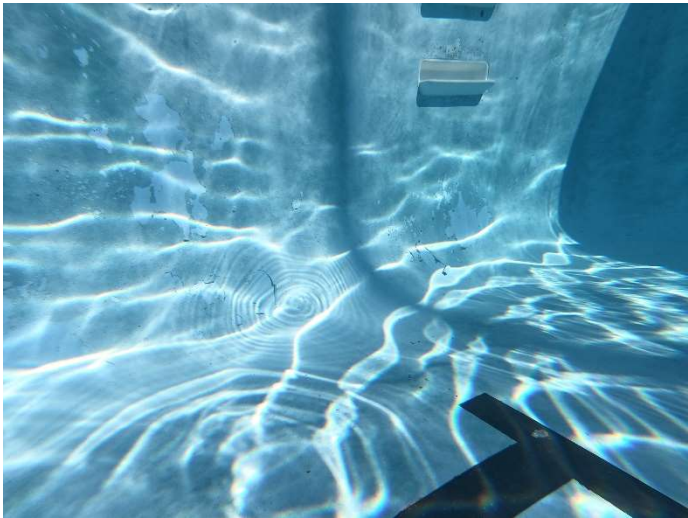
Pool paint peeling

- Pool paint interior is bubbling, cracking and missing in many places
- Waterline tiles are in poor condition – cracked, missing in multiple places
- Coping to top of pool is drummy and failing significantly over the entire pool

We would suggest that cosmetic repairs (tile, paint and capping) be done in conjunction with the leak repair works

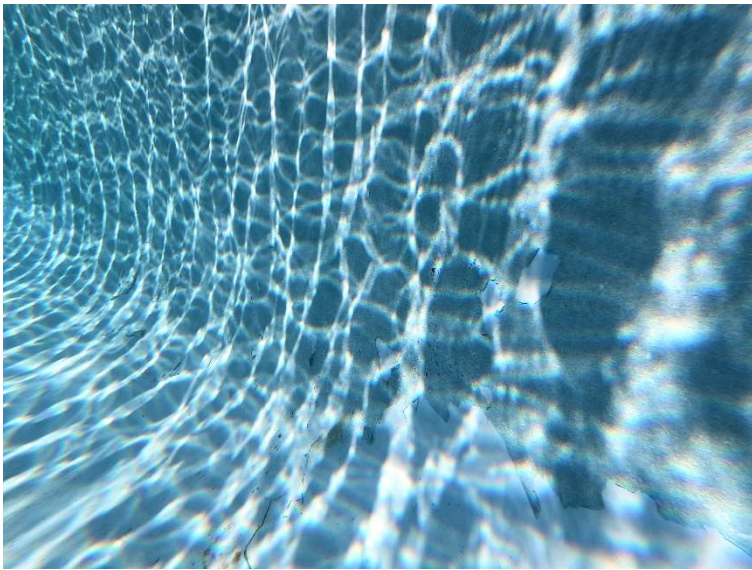
Pool Paint peeling

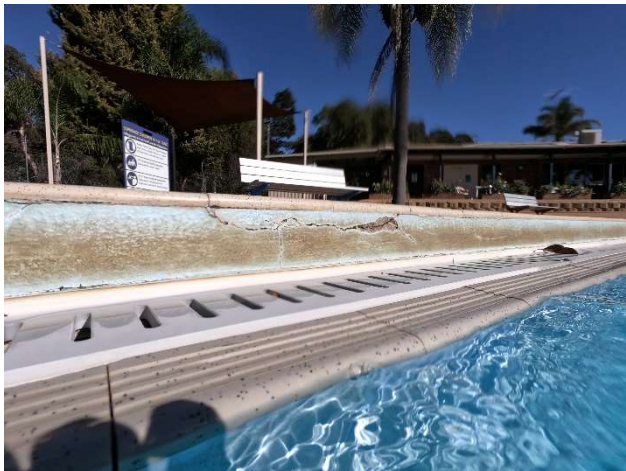
Capping screed cracking

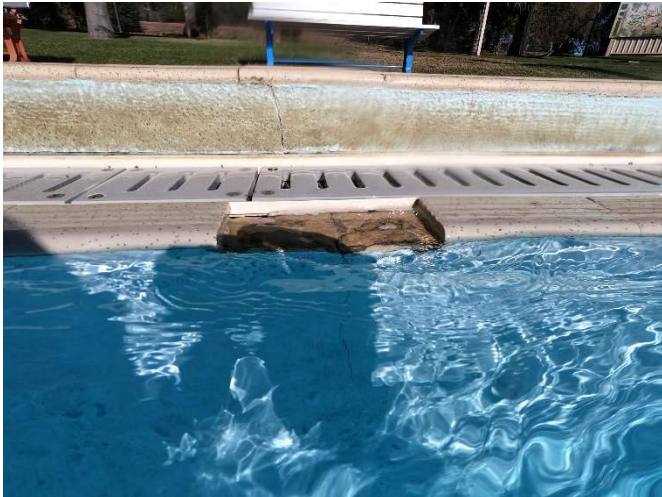
Edge tile missing

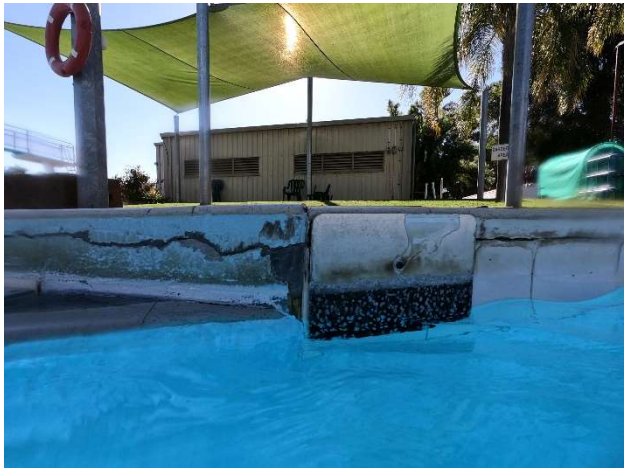
Capping screed cracking

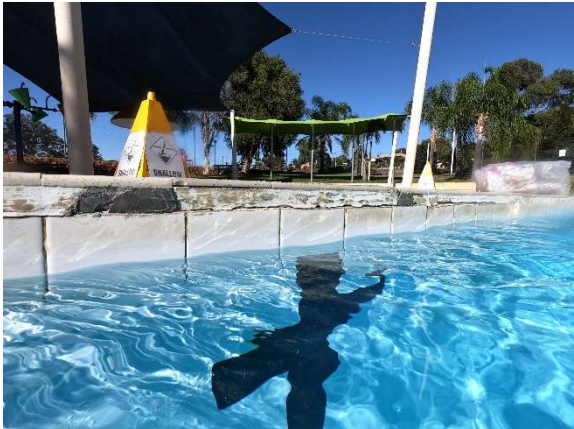
Capping screed cracking/drummy

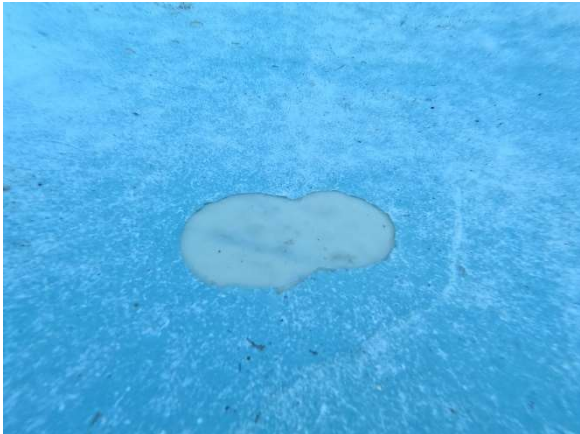
Existing repair in floor

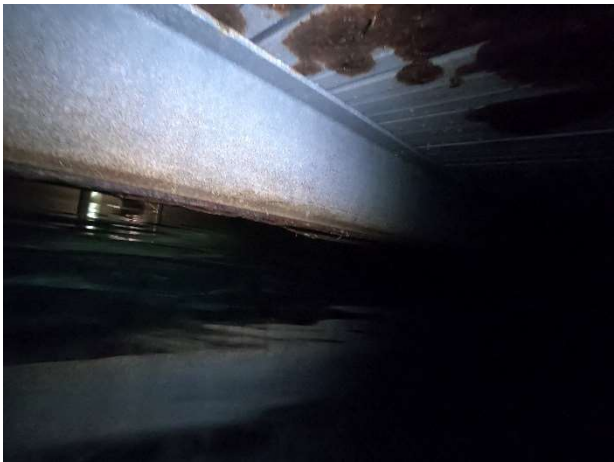
Balance tank I Beam rusting on lower section

- Balance tank internal condition in acceptable condition
- Balance tank penetrations showing no signs of leaking
- Balance tank I Beams showing small signs of rusting

Galvanised i beams have small signs of surface rust.

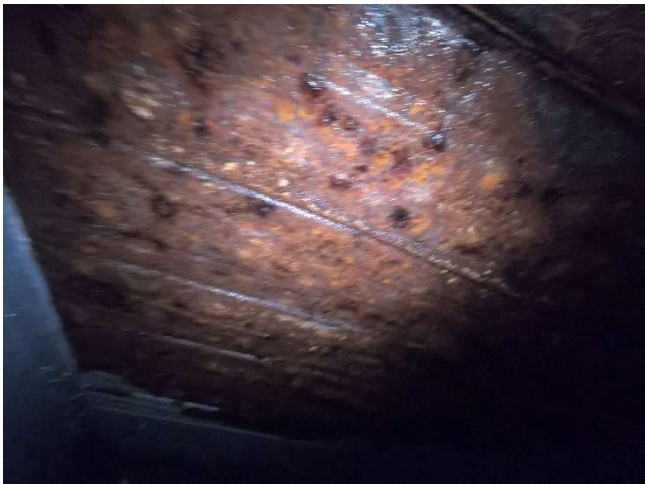
Balance tank Bondek lid rusting

- Balance tank Bondek material on underside of tank lid is rusting
- It is unclear whether metallic furniture and objects around the pool have been equipotentially bonded.

Bondek formwork above showing signs of significant rust.

We believe there is no compromise to the structural integrity of the balance tank lid, however if there are further concerns, a suitably qualified structural engineer should be engaged

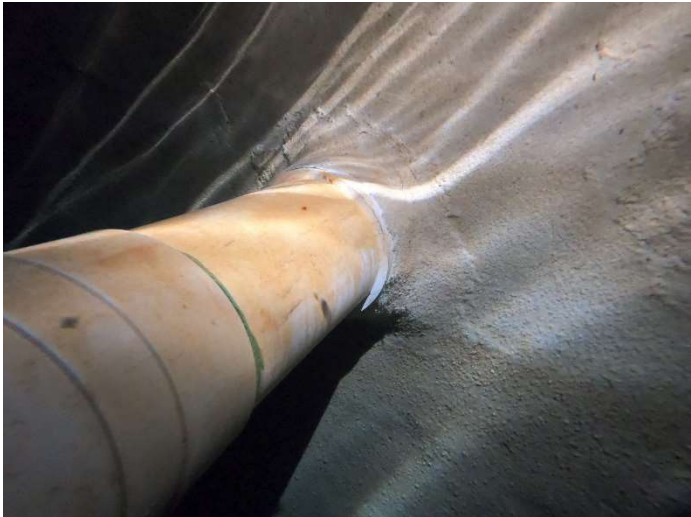
Balance tank penetrations – NO LEAKS

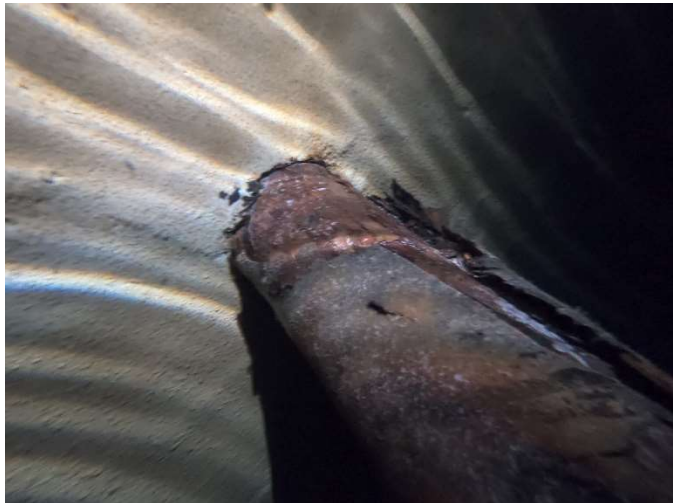
Original pipe penetrations – NO LEAKS

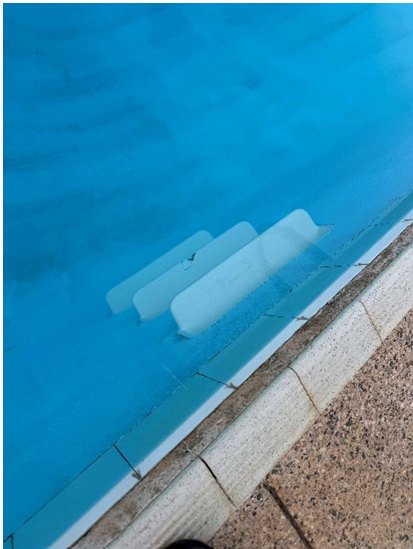
Access steps damaged

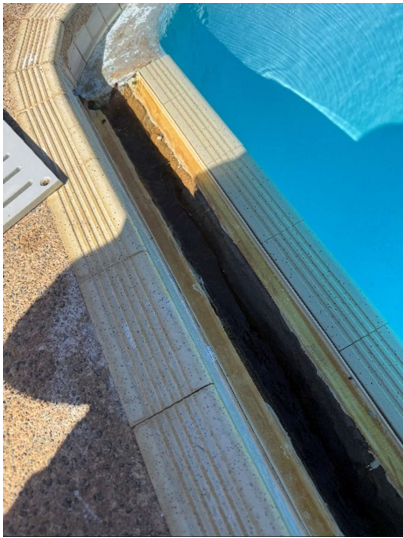
Pool gutters – no signs of leaks

- Gutters are in OK condition – no signs of leaks however bare concrete showing signs of age
- Gutter pipe from gutters to balance tanks show no sign of leaking

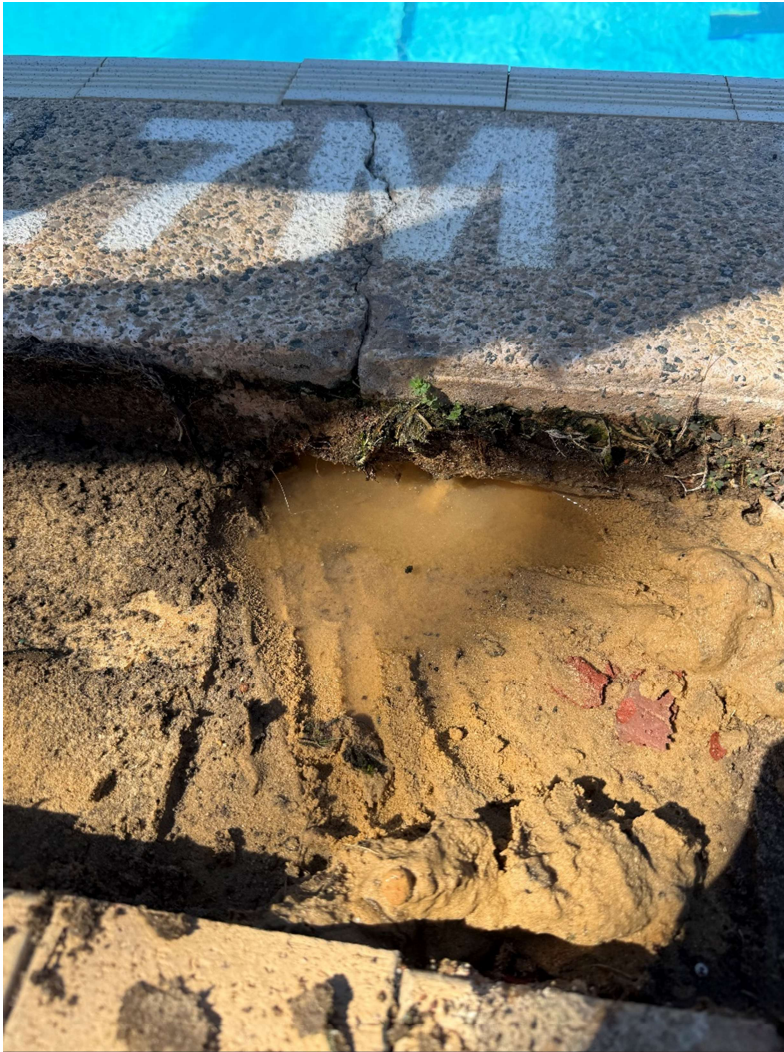
Control joint to pool leaking at dive bowl area
