**Attachment 9.2.1A**

**SHIRE OF BOYUP BROOK  
MONTHLY FINANCIAL REPORT  
FOR THE PERIOD ENDING 30 JUNE 2024**

LOCATION PLAN - PROPOSED DEVELOPMENT INVESTIGATION AREA  
 Boyup Brook - Arthur Road  
 Boyup Brook

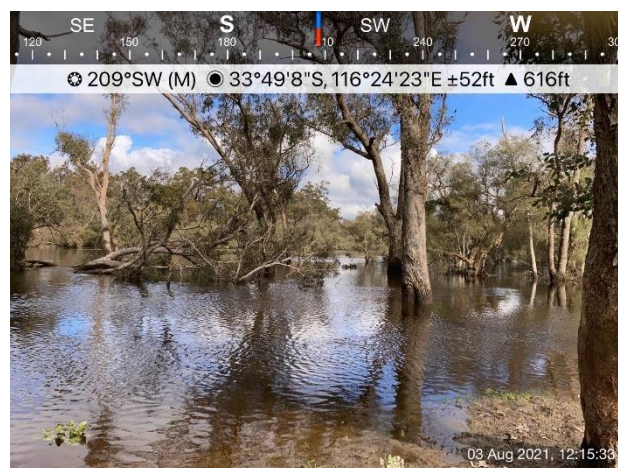
**Photo 8: The Blackwood River fronting the Subject Site near the location of TP4. Flood levels extend beyond the river channel to the outer edges of the riparian zone outside of the Subject Site.**
