## Attachment 9.2.1A

LOCATION PLAN - PROPOSED DEVELOPMENT INVESTIGATION AREA  
 Boyup Brook - Arthur Road  
 Boyup Brook

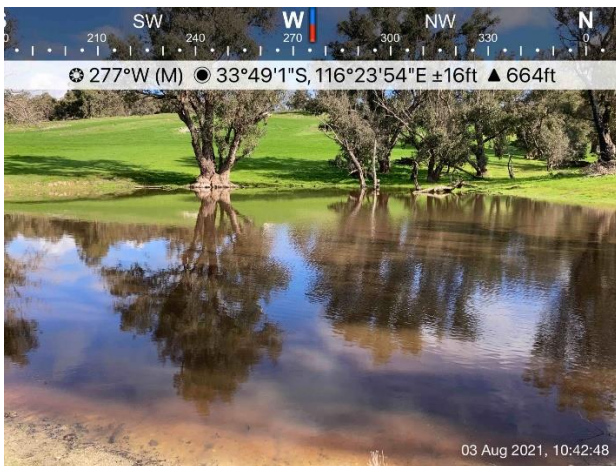
**Photo 1: A dam located in the upper reaches of the western creek line, which provided a trickle flow of water to the lower reaches of the creek during the site investigation.**

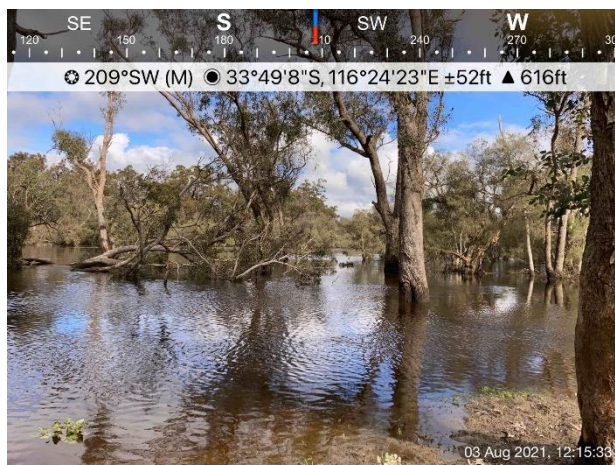
**Photo 8: The Blackwood River fronting the Subject Site near the location of TP4. Flood levels extend beyond the river channel to the outer edges of the riparian zone outside of the Subject Site.**

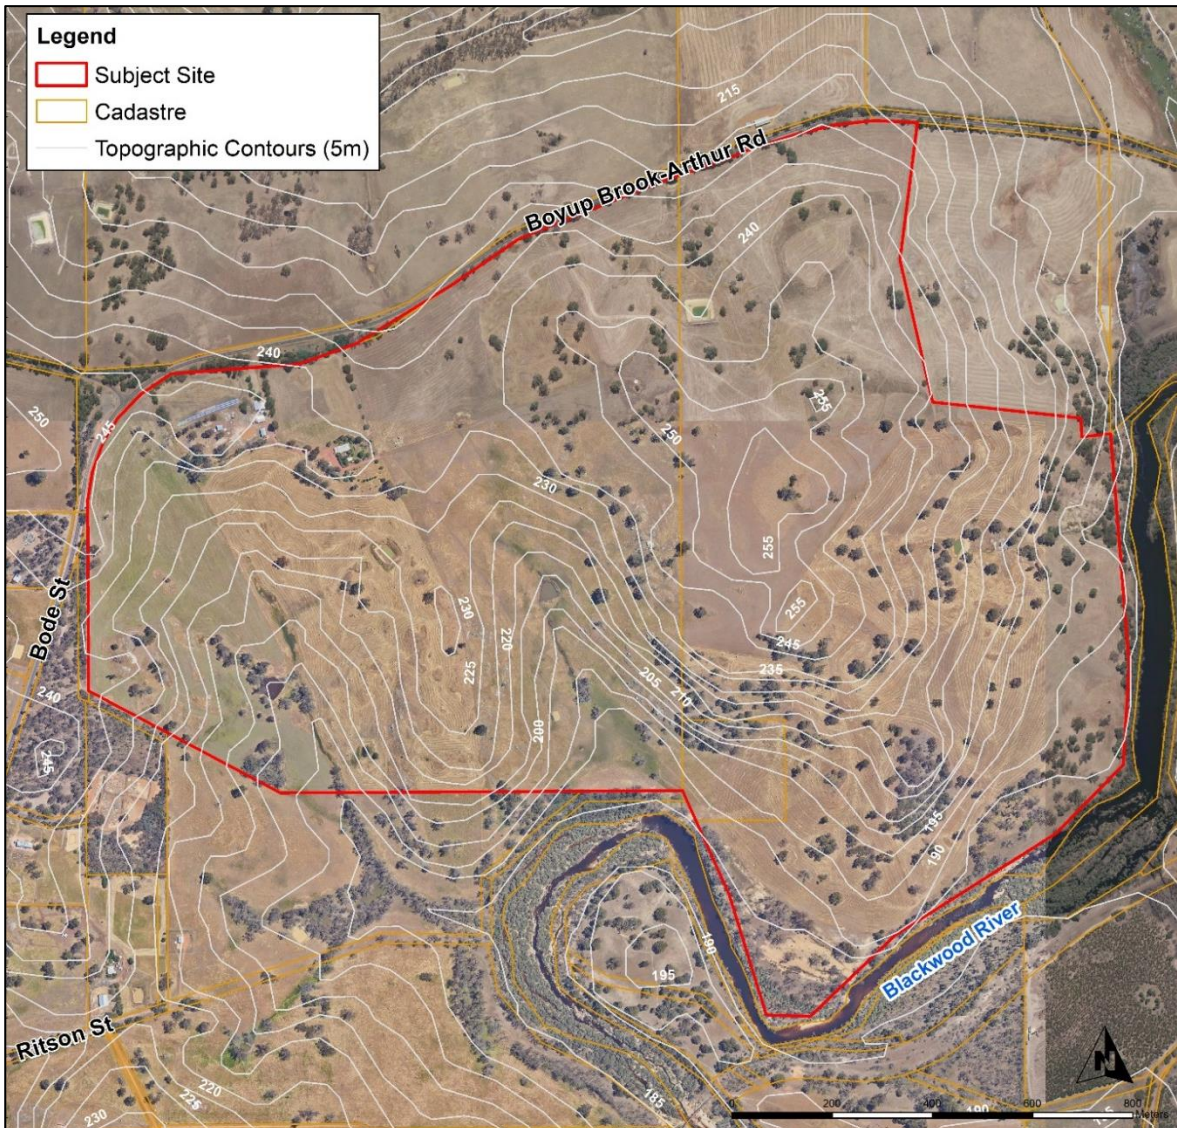
Figure 3: Topography

The Subject Site generally slopes from northwest to southeast towards the Blackwood River, from a high point of 255 m AHD in the central portion of the site to 180 m AHD along the Blackwood River foreshore in the southeast and east of the site. A smaller portion of land in the north of the site slopes back towards the Boyup Brook-Arthur Road which lies at approximately 225 m AHD. Topographic contours (5 metre) for the Subject Site are shown in Figure 3.

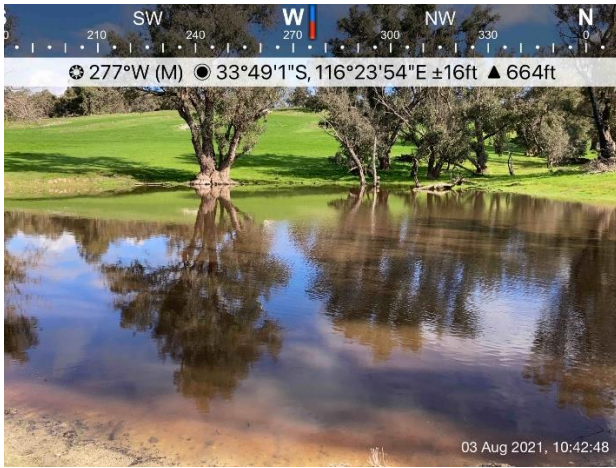
**Photo 1:** A dam located in the upper reaches of the western creek line, which provided a trickle flow of water to the lower reaches of the creek during the site investigation.

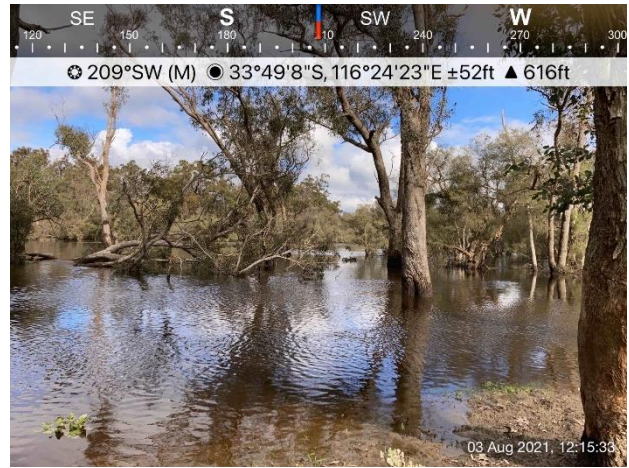
**Photo 8: The Blackwood River fronting the Subject Site near the location of TP4. Flood levels extend beyond the river channel to the outer edges of the riparian zone outside of the Subject Site.**

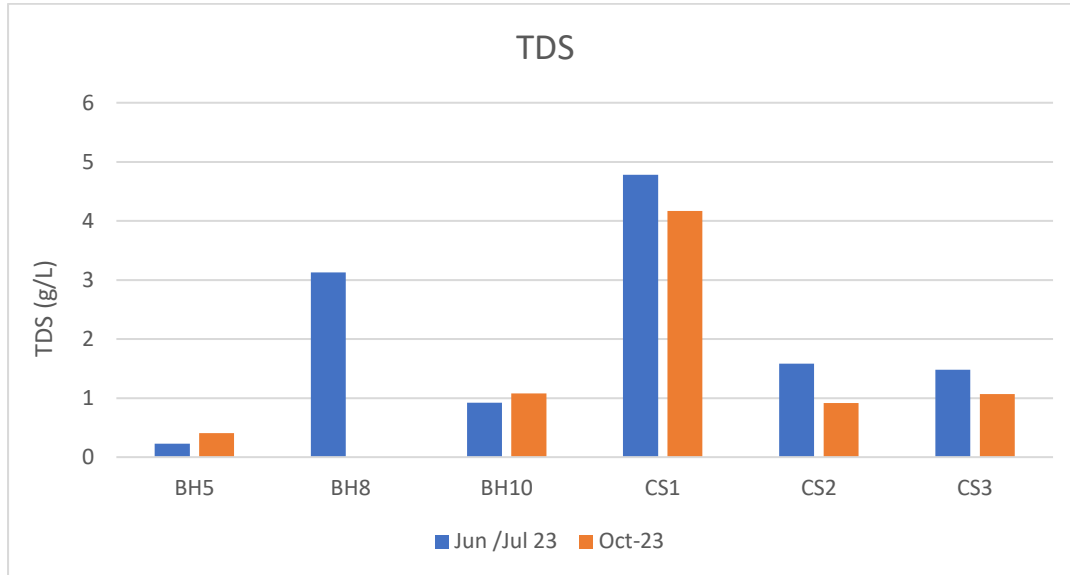
Figure 4: Surface water and groundwater TDS

TDS levels across the site were found to be slightly elevated at BH10, CS2 and CS3 and high at BH8 and CS1. TDS levels were found to be above the ANZECC and ARMCANZ (2000) upper trigger value (1 g/L) at all monitoring sites except for BH5, BH10 (Jun/Jul 23 only) and CS2 (Oct 23 only). TDS levels at each of the monitoring sites during the two monitoring rounds are shown in Figure 4, with the TDS data shown in Appendix B.
